PRESS RELEASE

ARCHAEOLOGICAL EXCAVATIONS CONDUCTED BY THE UNIVERSITY OF SYDNEY'S ARCHAEOLOGICAL MISSION TO NEA PAFOS, 2015

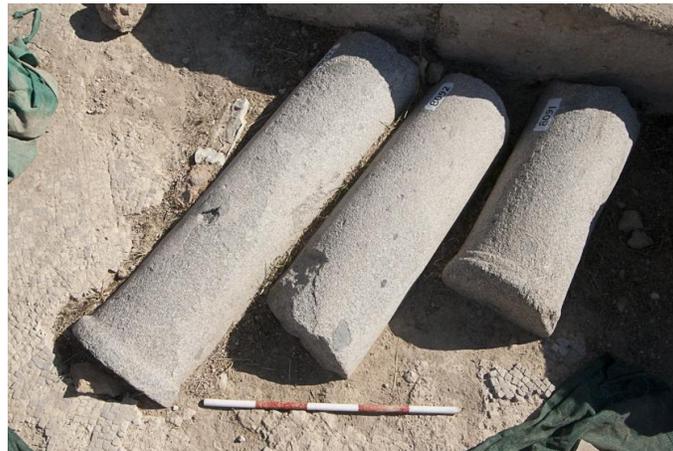
Image 1: Troad granite column fragments.

The columns are made from granite from quarries in Troad in Turkey and reflect Roman trade in monumental architectural elements. Troad granite columns are known from colonnades across the Mediterranean. As the capital city of Cyprus at the time, it is not surprising that Nea Pafos would be adorned with this architectural demonstration of Roman civic order.

The survey of the visually identifiable surface granite column fragments of Nea Pafos located some 167 individual column fragments; all in secondary or subsequent usage. Many were reused in the construction of later buildings such as Saranda Kolones and the Early Christian basilica at Chrysopolitissa. Others have been incorporated into modern walls, fences, fountains and gardens. The team recorded each column fragment in detail; and its precise position was recorded using Total Station and survey grade GPS. Using the gathered data, each column has been plotted onto maps, which indicate that there are two distinct axes on which the majority of column fragments align. Those that don't align were moved for a specific purpose, such as for the construction of Saranda Kolones.

It is hoped that future targeted excavation of the road south of the theatre may reveal more of the granite columns, hopefully *in situ*, which will give an indication as to the spacing of the colonnade. The survey of Troad granite columns has revealed that those used in Nea Pafos fall into three main categories of size; a smaller series found mainly at the theatre, a middle type with a height equivalent to 16 Roman feet (around 4.6 metres) and the largest, but least common, type that stood at 24 Roman feet (over 7 metres).

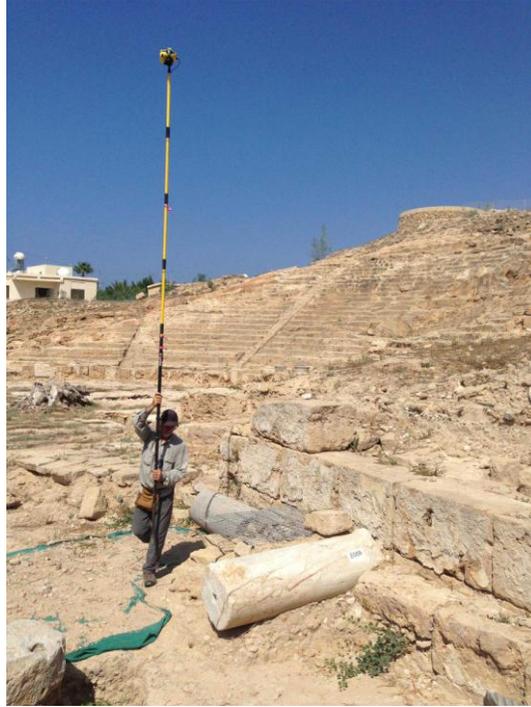
Image 2: A member of the team conducting a pole photograph survey on the site of the ancient theatre.

In addition to the colonnade survey, the ancient theatre was recorded for the first time using pole photography and photogrammetric programs which stitched together over two thousands individual high resolution photos. This orthographically correct 3D image of the ancient theatre and surrounding areas of Fabrika created by the pole photography project will assist with planning future excavation areas and understanding the urban layout of the town in the area around the ancient theatre.

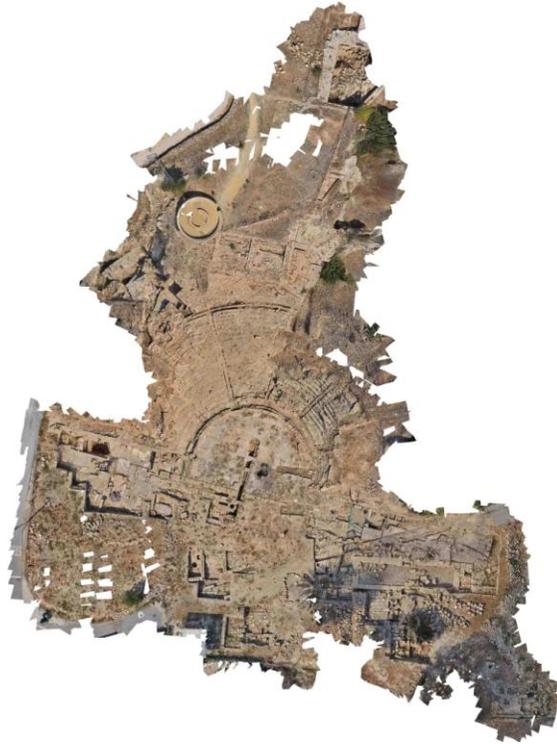
Image 3: The photogrammetric image of the ancient theatre and Fabrika.
